FIGHTING VEHICLES  
RESEARCH AND DEVELOPMENT  
ESTABLISHMENT

REPORT No. T.R. 80

FOURTH DEVELOPMENT FIRING TRIALS OF  
81mm MORTAR IN A.P.C. F.V. 432

This report describes a Fourth Development Firing Trial held at the Proof and Experimental Establishment, Pendine, in November, 1964, of the 81 mm Mortar on a floor mounted adapter fitted with a monopod in FV.432.

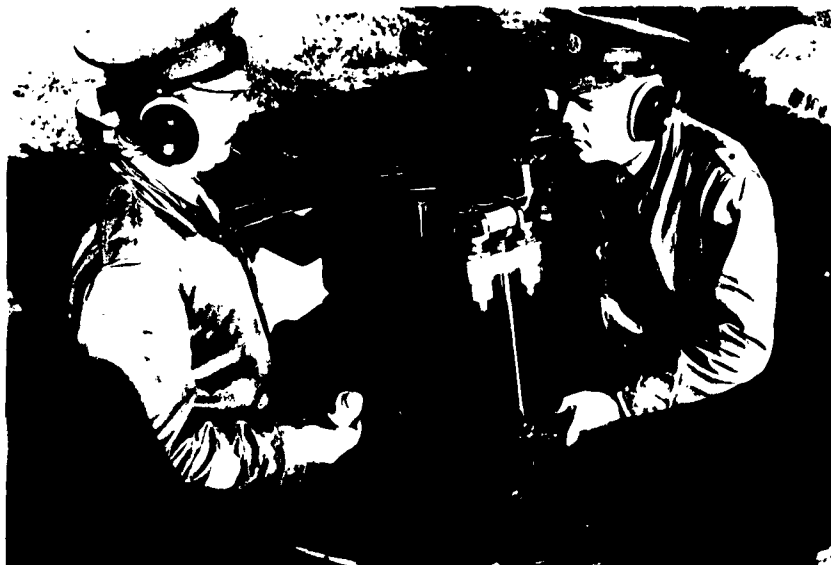
FIG. 5

QMSI L. Shepherd waiting  
to load.

QMSI K. Pinkard laying.

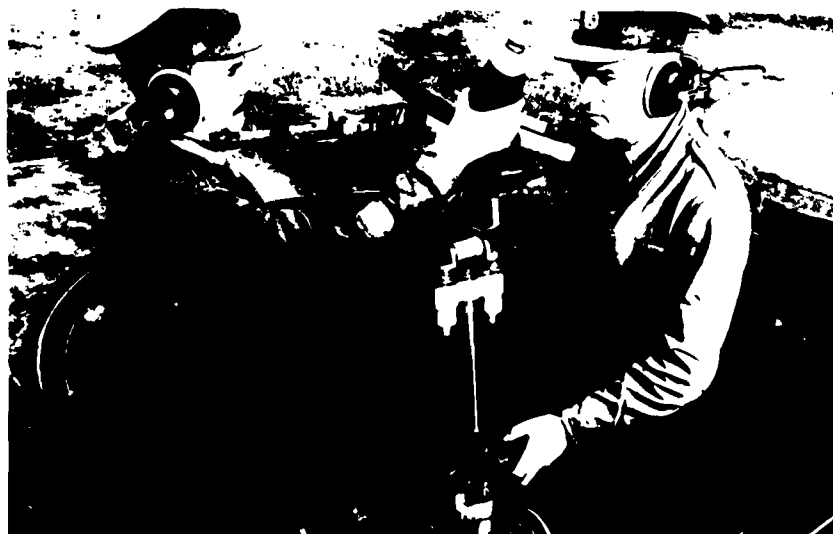
FIG. 6

QMSI Shepherd loading.

QMSI Pinkard watching the  
bubbles in the sight.
